Reinforcement markings on road maintenance vehicles  
with UK Battenburg patterns  
Evaluation of the speed reducing effect

Johan Granlund, Stefan Hedlöf and Tommy Nilsson

**Enhanced marking of road maintenance vehicles with so-called Battenburg patterns.**

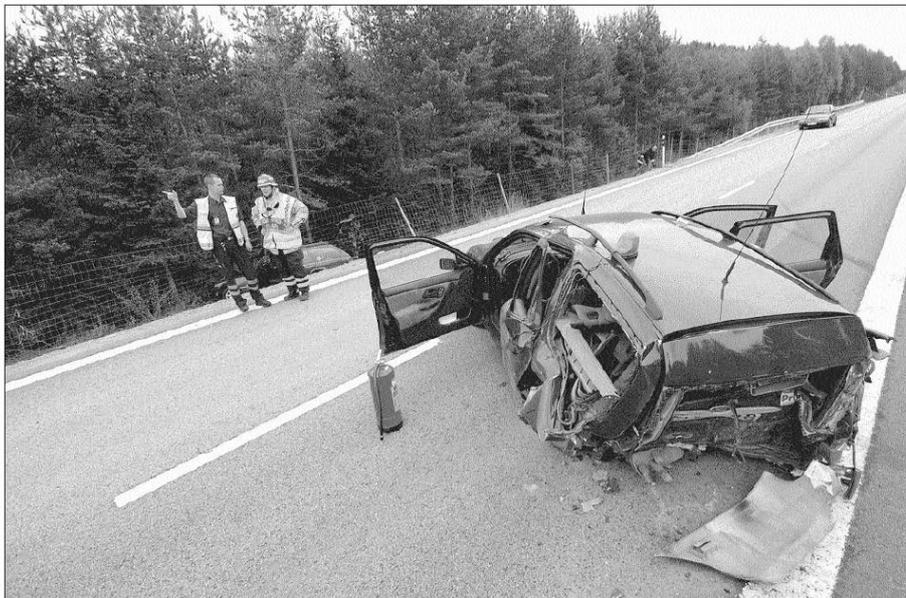
Vägverksanställd svårt skadad. Olyckan inträffade på riksväg 80 utanför Falun på torsdagseftermiddagen. Vägverkets fordon blev påkört och en person som satt i bilen skadades svårt. Foto: KJELLJANSSON

Figure 1 - Road maintenance vehicle hit by a car in connection with the rebuilding of freeway 2 +1 road

Many accidents manifest on the road by not paying enough attention to road maintenance vehicles. Figure 1 shows an example of a violent rear-end collision. Road workers hit in the vehicle died later in hospital. It is obvious that road maintenance vehicles must be [effectively] marked out and more visible!

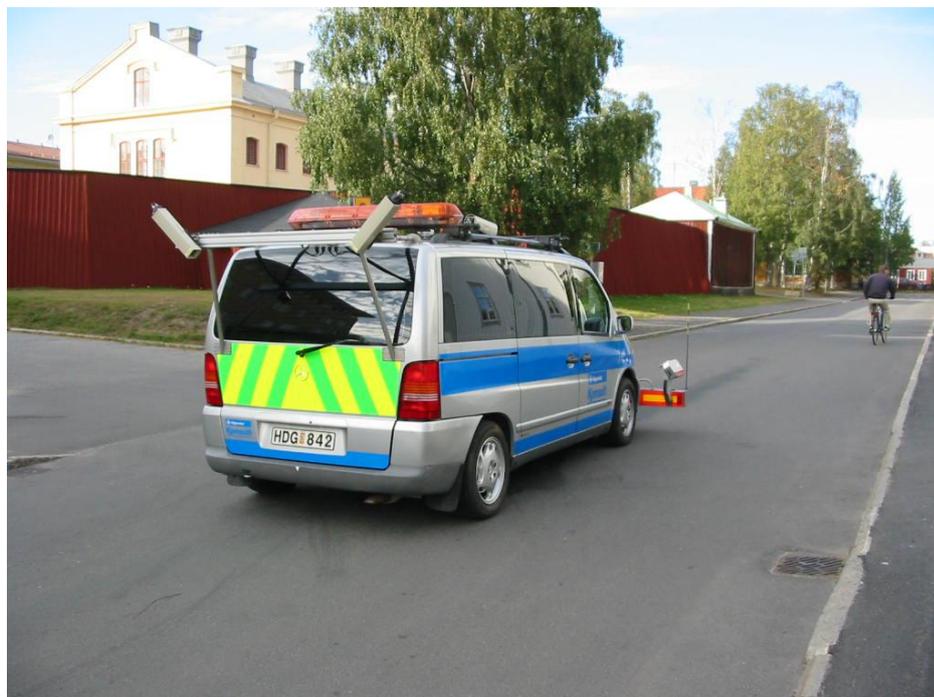
Figure 2 - Older chevron marking in yellow + green colour is no longer allowed for road maintenance vehicles.

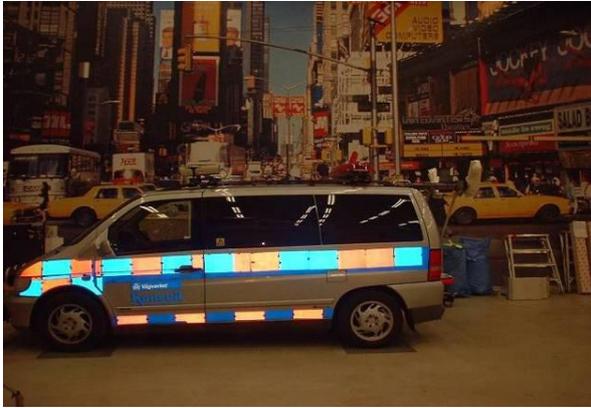
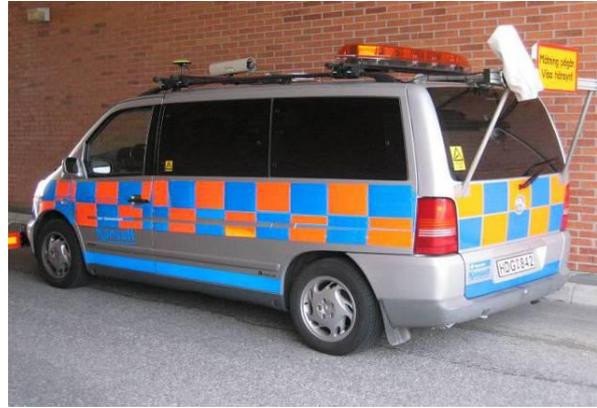
Figure 3. Test of alternative markings on Profilograf P16 at Factory Fire

The group of road workers who received the new yellow/green marking on their vehicles did not remove them, but got them replaced with an equivalent marking. Other road workers then called for enhanced marking of their vehicles. In June 2005, the SRA conducted a full-scale test of alternative warnings in cooperation with 3M and the Factory brands. A handful of patterns using orange/blue box patterns were tested, see Figure 3. The material is intensely reflective in the dark and luminous (fluorescent) in daylight.

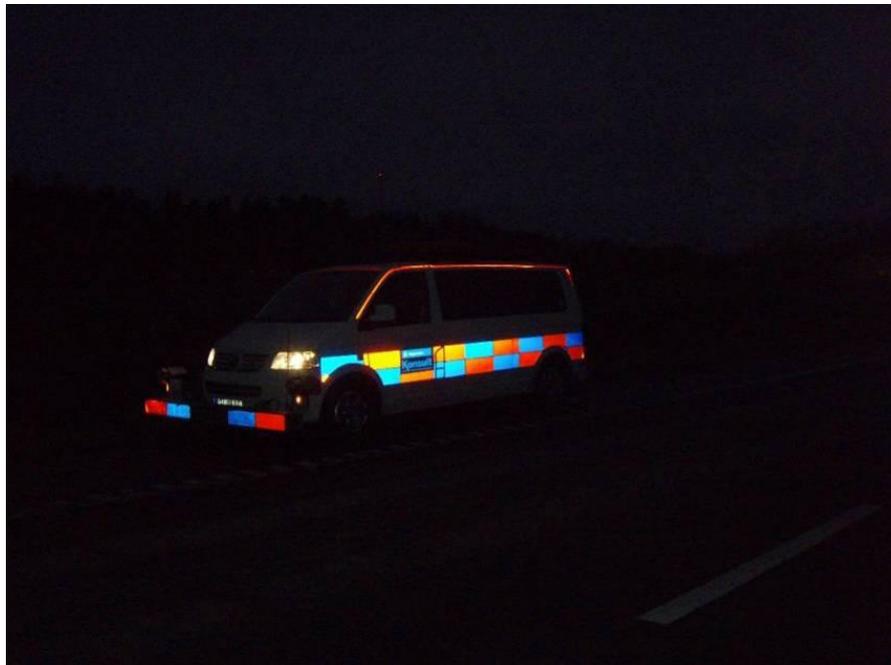
Figure 4. Approved markings - Battenburg rectangular boxes in 1:3 format

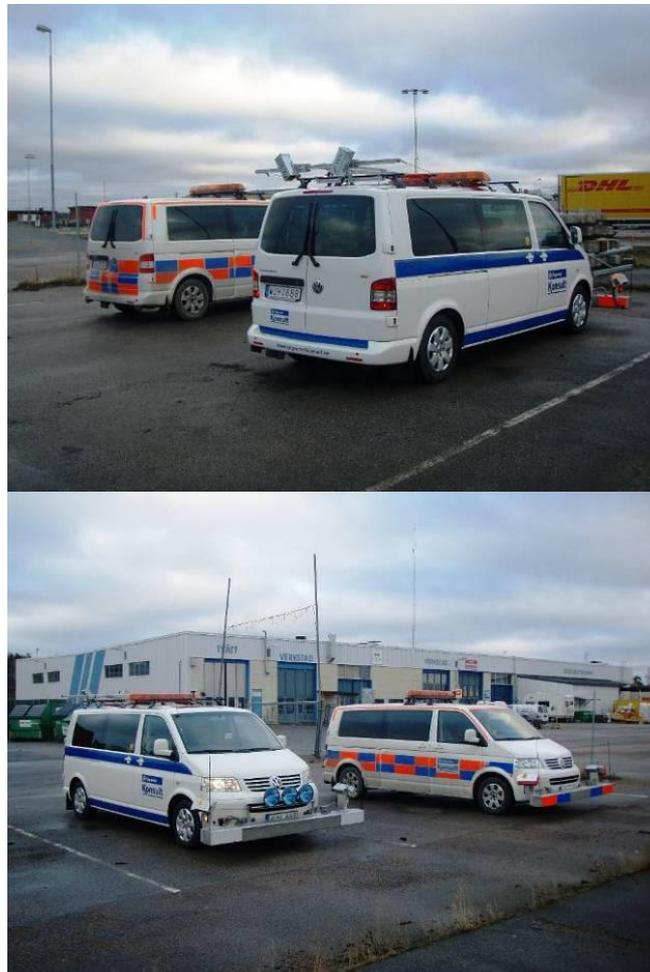
Figure 5. Trial Vehicles with and without Battenburg Markings

The evaluation was done using a Profilograf laser on two measuring cars, P43 and P45, see Figure 5. The measuring cars are built on identical VW Caravelle minibuses and fitted with a 2.5m wide metal support beam on the front which is fitted with lasers to scan the condition of the road surface.

On one car - P43 - the tests were undertaken with the usual (but reflective) corporate decals on the front and sides with rear lighting. The other car - P45 – was fitted with Battenburg fluorescent and highly reflective orange / blue markings affixed all around the vehicle.

The cars had identical flashing lightbars on the roof which were illuminated for all measurements during the tests. Both cars are painted white, which is statistically the colour at lowest risk of collision.

The Battenburg marking has a large surface area on the rear of the vehicle; see the photos in Figure 5 and Figure 7. In front, only the low-set measuring beam carried enhanced markings. Thus it is reasonable to expect greater speed dampening effect on the following vehicles, rather than the oncoming vehicles. By driving the measuring car in normal traffic patterns there will be very few numbers of overtaking or on running vehicles. In addition, overtaking or on-running vehicles found their driving affected by other random factors largely unrelated to this evaluation. For example, a "speed fool" who tends to drive very fast will be delayed by the oncoming traffic and ends up in the queue behind the measuring car. These factors meant that the number of on-running vehicles registering in the test was very low and their speed so driven by random factors, that analysis of overtaking or on-running traffic cannot give results with a reasonable statistical certainty. Therefore, this type of data was rejected. The analysis therefore focused on the speed of the oncoming vehicles; however results from this analysis showed no apparent reduction in the approach speed with Battenburg markings displayed.

Radar resolution is 0.1 km /h and the accuracy is about 1 km/hr. The uncertainties of the measurement set is, compared to the speed damping effects measured, small enough to not affect the conclusions. The blue company marker at the rear and sides of the reference vehicle P43 (see Figure 5) was reflective and therefore was something more spectacular than many regular "temporary road maintenance vehicles." Furthermore, the P43 has three large blue lights. P43 can possibly have given some road users the impression of being an (older) police vehicle and thus have had some speed damping effect. This means that enhanced markings in the Battenburg pattern can provide even greater speed damping when mounted on vehicles with a history of the less-conspicuous company marking. Extra lights are affective nevertheless notwithstanding the important results of speed reduction at the inspection stops, as they relate to the following vehicles but not oncoming vehicles. In any event, this study can hardly be overestimated due to the assumed Battenburg speed damping effect.

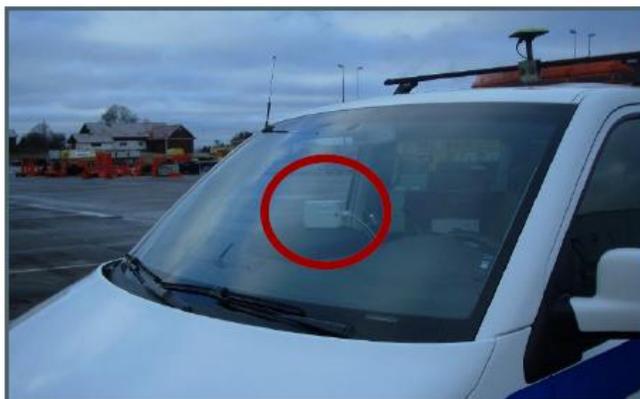
Figure 6 The radar unit mounted forward in the Profilograf measuring vehicle

The speed of oncoming vehicles respectively *running* was measured with Sierzega SR3 radar units mounted inside the *graphic profiler*. The forward-looking radar was set on the dashboard at a 33-degree angle towards the traffic, see Figure 6. The rearward facing radar was mounted at a 19-degree angle. In all cases the radars sat at 1.4 m above the road. Radar accuracy is less than 1 km/h, ie the measurement is better than the typical original vehicle-mounted speedometer.

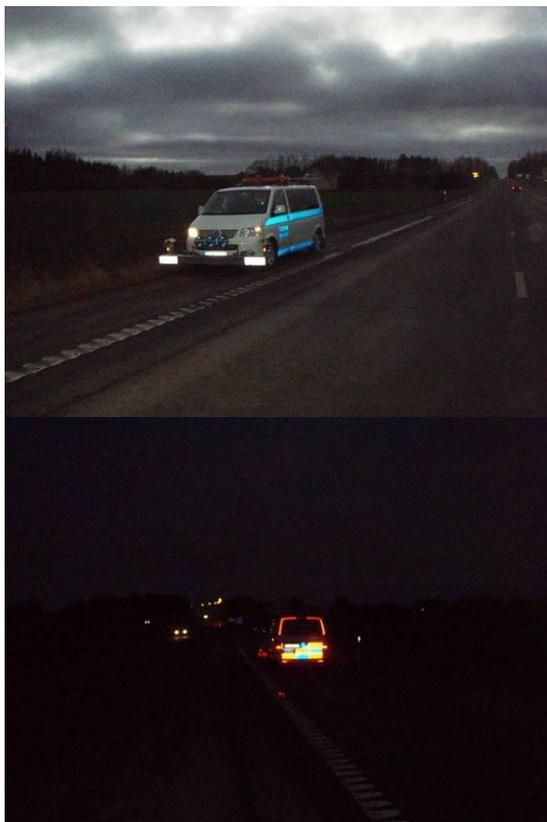
Figure 7. *Inspection stop* on the hard shoulder (the flashing lights were turned on, but they are not visible in the photo)

The test stretch consisted of 52 km of road, the route 793/215 Linköping to Finspång. The tests were carried out in daylight and in darkness. The testing was repeated at the same time on following days in order to eliminate any timing variations in traffic composition. The crossover means that the tests were done with Profilograf P43 in the afternoon on day 1 and repeated with the P45 over two days. Two roadwork operations were tested. The first trial was a classic test called the *Inspection stop*. The measuring car was simply parked on the roadside, see Figure 7 and Figure 8.

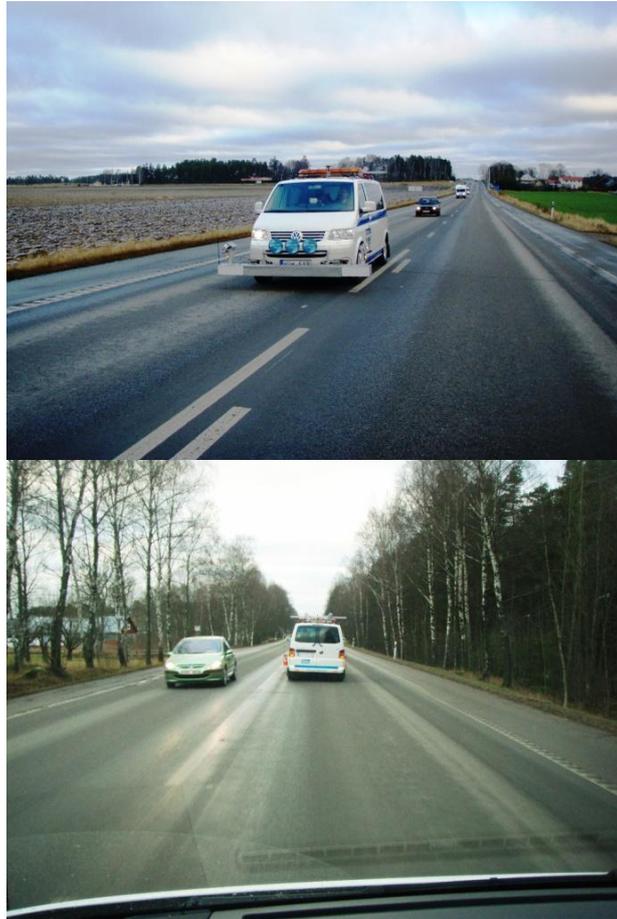
Figure 9. Centre of lane measurement of normal traffic patterns

The second test was a moving trial where the measuring cars simulated the testing of the lane centre measurement for asphaltting work, see Figure 9 and Figure 10. The measuring cars ran along the centre of the lane in the normal traffic pattern. Therefore, the vehicle moved the radar with the measuring car at speed. Profilograf systems are an extremely sensitive odometer logging the measured car speed, so the radar readings can be calibrated for accurate measurements of road speed.

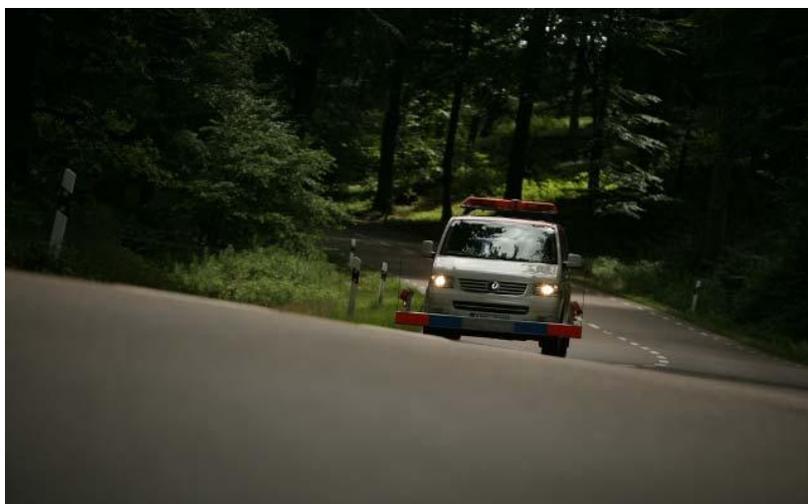
Figure 12. Hood, bumpers and mirrors can be used to increase the frontal area highlighted at the eye height

The loss of speed dampening effect on the oncoming traffic may indeed have masked the perhaps too simple overall calibration. Another reason may be that the frontal surface of Battenburg marking on the metal beam is very small and associated with a lower level, see Figure 12. These point to a need for road maintenance vehicles to be highlighted more on the front. In the specific case of the road surface measuring cars, the staff are keen that the measuring beams are not extended and therefore it is important that the protruding parts are already highlighted. Extensions of any markings should be placed on the bumper, bonnet and rear-view mirror housing. It is important that any markings on the hood do not instigate any unwanted reflections towards the operators. However, this is probably a very low risk.
